# STREAM RESTORATION

Longmont Dam Road

## Colorado Flood Recovery: Watersheds and Natural Resources

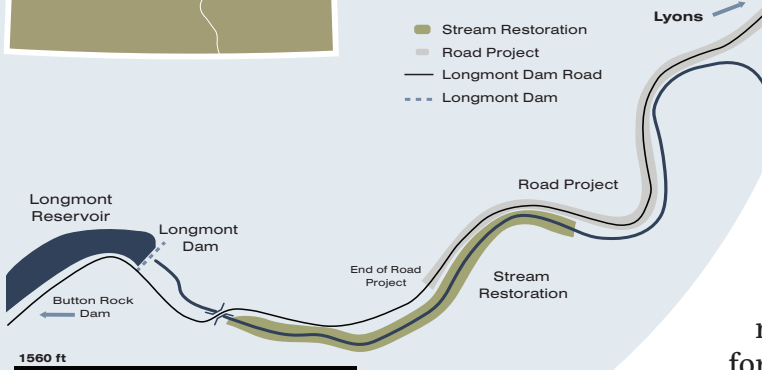
## North Saint Vrain Creek

The overall restoration goal was to restore the stream channel and improve the North Saint Vrain Creek in-stream aquatic habitat and riparian ecology. This project included excavation and configuration of creek benthic material to create, enhance and protect aquatic riffle, pool and run habitat; placement of large rock structure to provide benthic habitat stability and maintain creek resilience; placement of habitat rock and features for structure and flow; and revegetation of riparian areas. The channel was narrowed to keep it deeper in one spot and put structure in to take pressure off of the banks in future high water events.

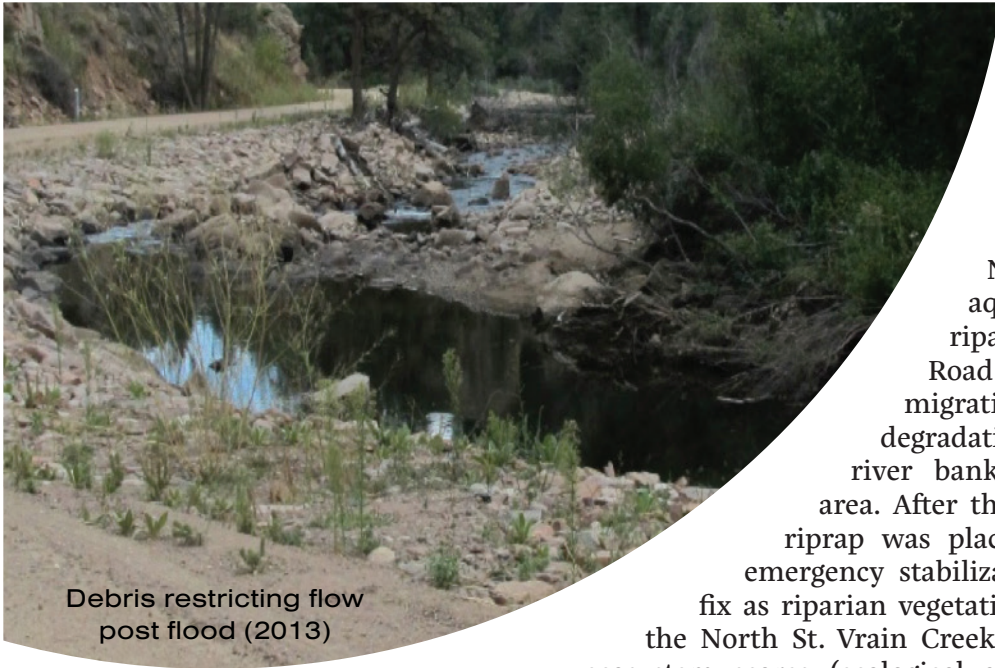
Debris restricting flow post flood (2013)

During the 2013 flood event, flood waters scoured tons of rock, woody debris and silt from this section of North St. Vrain Creek, disrupting aquatic habitat and removing adjacent riparian vegetation. Longmont Dam Road was washed out and channel migration and sediment aggradation and degradation occurred, destabilizing the river banks throughout much of the project area. After the flood, the roadway was rebuilt and riprap was placed between the road and creek for emergency stabilization, but this was not a permanent fix as riparian vegetation was not restored. By July 15, 2015, the North St. Vrain Creek received only “fair” to “good” overall ecosystem scores (ecological assessment by Walsh Environmental), as most of the system had a narrow riparian corridor with large gaps in vegetation and limited canopy cover with some habitat complexity. There were also several substantial in-stream structures that broke up the stream flow and created barriers for fish passage.

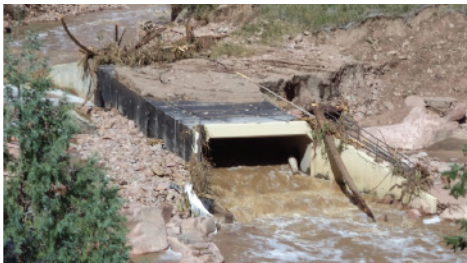
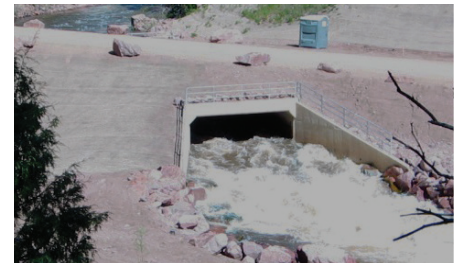
2013 flood waters significantly damaged this section of North Saint Vrain Creek. These photos show a culvert on Longmont Dam Road just upstream of the current restoration project post flood and after initial repair to the road.  
(Photos: City of Longmont)

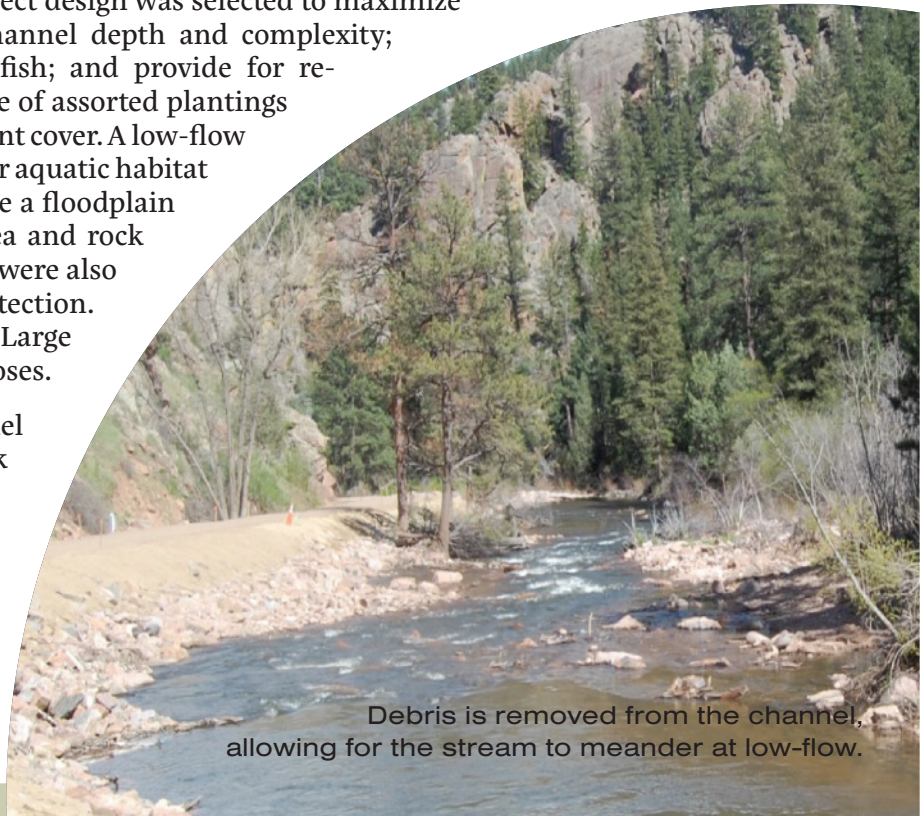
Debris is removed from the channel, allowing for the stream to meander at low-flow.

Design criteria were developed to accomplish permanent restoration based on the post-flood state of the creek. Above the Longmont Dam, there was an area of stream reach that was undisturbed by the flood that was used as a reference. Two design flows were evaluated. Project design was selected to maximize habitat connectivity with good low-flow channel depth and complexity; create deep water over-winter habitat for fish; and provide for re-establishment of riparian vegetation with use of assorted plantings to enhance the riparian vegetation to 70 percent cover. A low-flow channel was created to allow adequate flow for aquatic habitat year-round, along with a gravel bar to provide a floodplain bench that allows for a healthy riparian area and rock vanes to structure flow diversity. Large rocks were also added in select areas for increased bank protection. Contractors also created pools for fish habitat. Large rocks found on-site were used for these purposes.

Absent significant high flow events, the channel will likely remain stable once streambank vegetation has been re-established. The Button Rock and Longmont Reservoirs located above this section of creek also serve to manage flows. Creek restoration was necessary to achieve biological connectivity and restore natural beneficial function of the creek, but the channel was mostly left in its current (post-flood) alignment.
